# TOUGHNUTZ™

## SUPER DUTY HUB TOOL

#### PMITNZ250 - TOUGHNUTZ™ Hub Tool

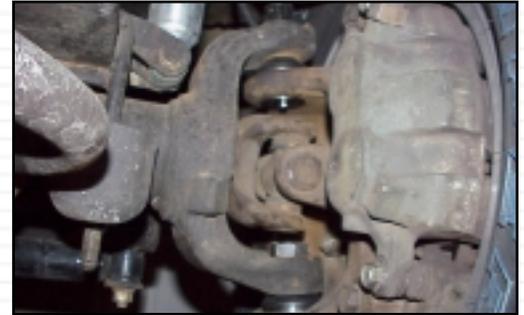
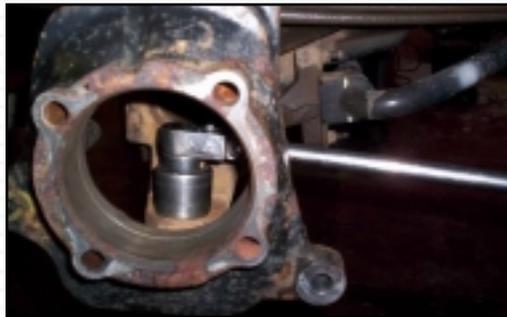
Actually the ball joints aren't hard to change, once you get to them. The manufacture claims the wheel bearing is a slip fit. This may be the case when the truck's new, but not once it's been in the mud or has any miles on it. The outer bearing race becomes frozen in the spindle. Most attempts to pull it out, from the wheel side, results in the bearing blowing apart. This not only doubles the cost of the repair, it locks down that bay while you struggle to get the outer race out. You then must ship the hub out to have the new bearing pressed on!
